Manhole Inspection Summary

Manhole # S41E__011MH

Insp Date: 1/14/09 1:53 PM

Location Address: **1200 e fayette st**

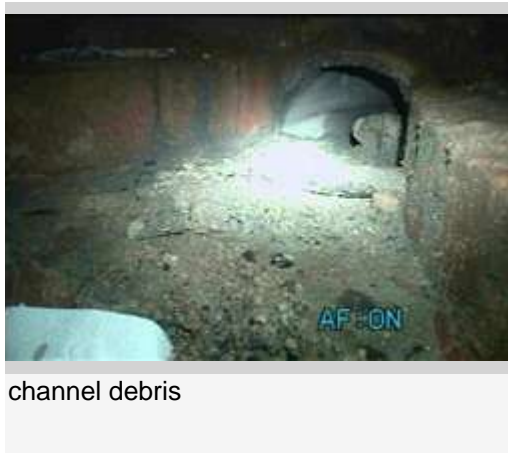
Defect 4

Condition: ☐ Sound ☐ Cracked ☐ Root Intrusion ☐ Deteriorated ☐ Leaks ☒ **Debris**

channel debris

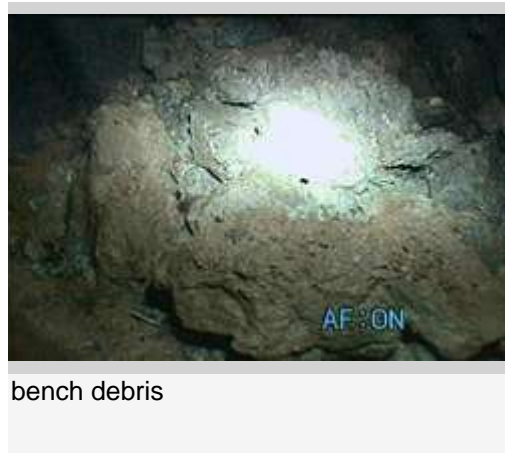
Defect 3

Condition: ☐ Sound ☐ Cracked ☐ Root Intrusion ☐ Deteriorated ☐ Leaks ☒ **Debris**

bench debris

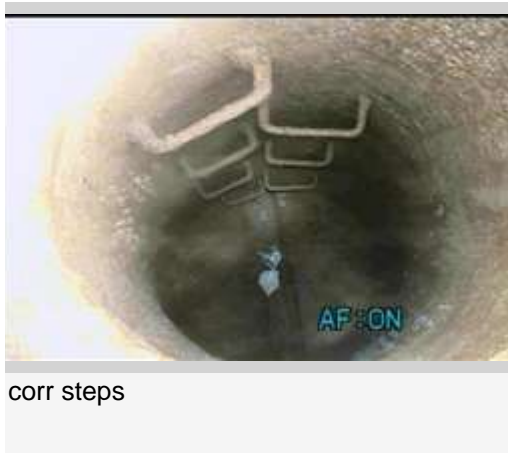
Defect 2

Count: **7** Missing: **0** ☒ **Corroded**

corr steps

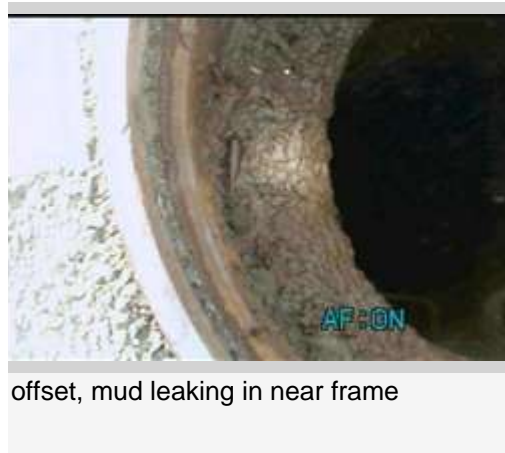
Defect 1

Offset: **6** (in.)

☒ **Leaks**

offset, mud leaking in near frame
